## Hong Kong Brewer #115 Calibration and Service Report – April 2010

Int'l Ozone Services (IOS) completed the annual calibration and service of Hong Kong Brewer #115 during the period of April 8-11, 2010. In the past year the standard lamp (SL) ratios R6/R5 have decreased by  $\sim 2\%$  (-30/-60 units), to values of 1630/3000, reference graph at bottom of this page. The weather did not co-operate well except for the final half day to allow some direct sun measurements.

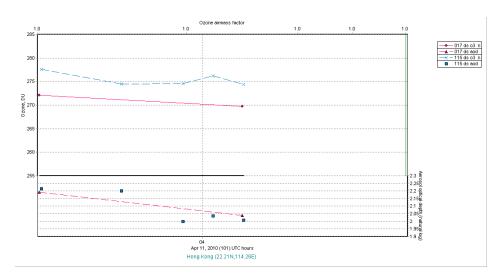
Below are the final ozone/AOD direct sun results from #115 and traveling standard instrument #017 during this visit. The ETC constants were corrected to values of 2848/2660 by applying the change in SL ratios, less 20 for the  $SO_2$  constant to improve agreement to #017. The AOD constants from 2005 were not changed. The new ozone constants file was named (icf07510.115) since this was day when ratios changed.

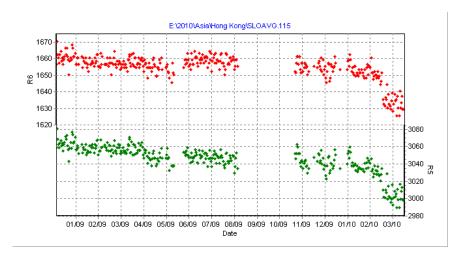
Next are the SL ratios for the past year showing change to values of 1630/3000 and note that the instrument was turned off for 2.5 months while the station was revised.

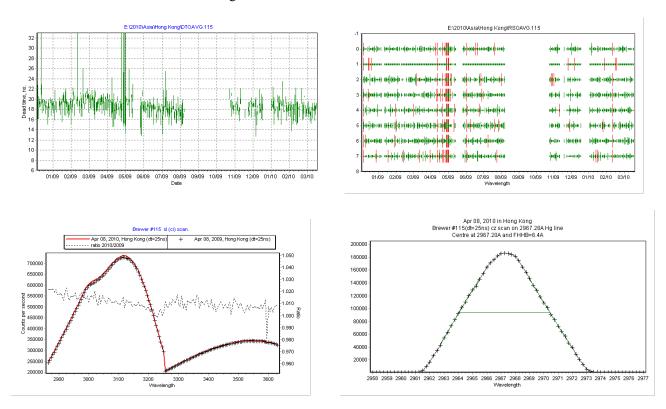
Below are graphs of the stable DT and RS test results for the past year and a scan of standard lamp compared to a 2009 scan. Then a CZ scan of Hg 2967A line, which shows normal slit function.

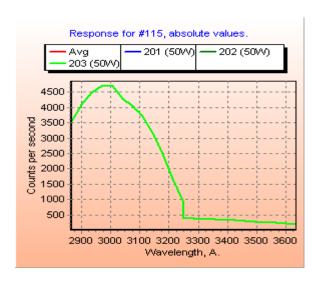
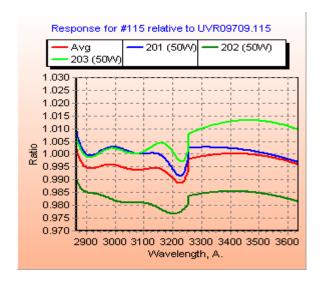
The UV calibration was completed and the new response file (uvr09810.115) compared well to file in use (uvr09709.115) and so no change is necessary. Wavelength accuracy was checked with dispersion test and when processed the results were very similar to constants in use (dcf06205) and so no changes were made.

Below is new response file calculated from IOS lamps #201, #202 and #203 and then the ratio to the 2009 file which shows ~-0.5% change in the past year.

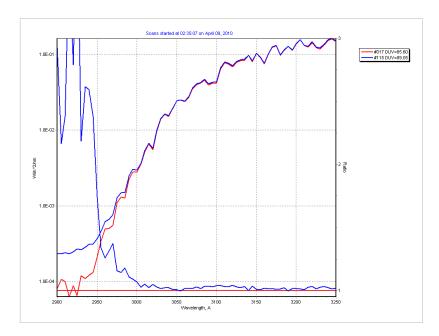
Below is graphing of near simultaneous processed UF scans from the two instruments on a cloudy day that show good agreement.
