Report on Brewer Spectrophotometers Calibration – Brazil, Bolivia – May 26-June 9, 2004

I. Overview and Instrument Status:

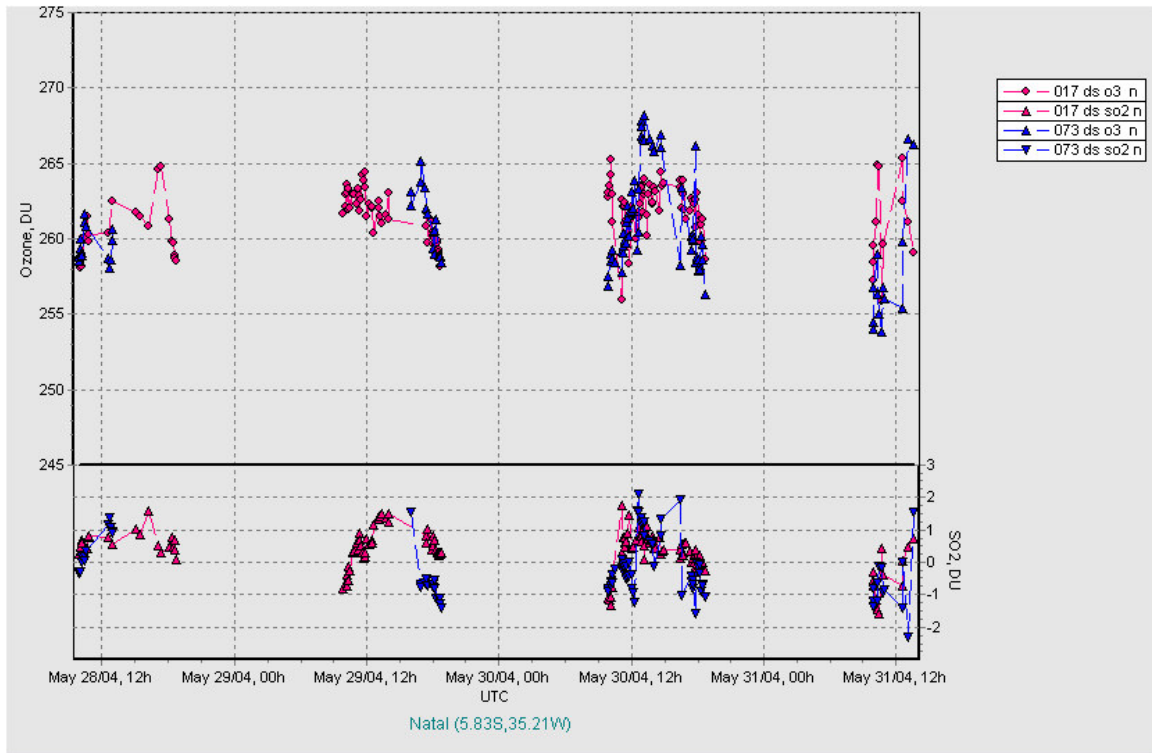
Below are the Natal final Ozone/SO₂ results over the four days with #017. For the first day the ETC constants were set to 2650/2240 for the initial calibration and then the rework was done on the instrument. The final ETC constants were 2870/2689 when standard lamp ratios were 1690/3210.

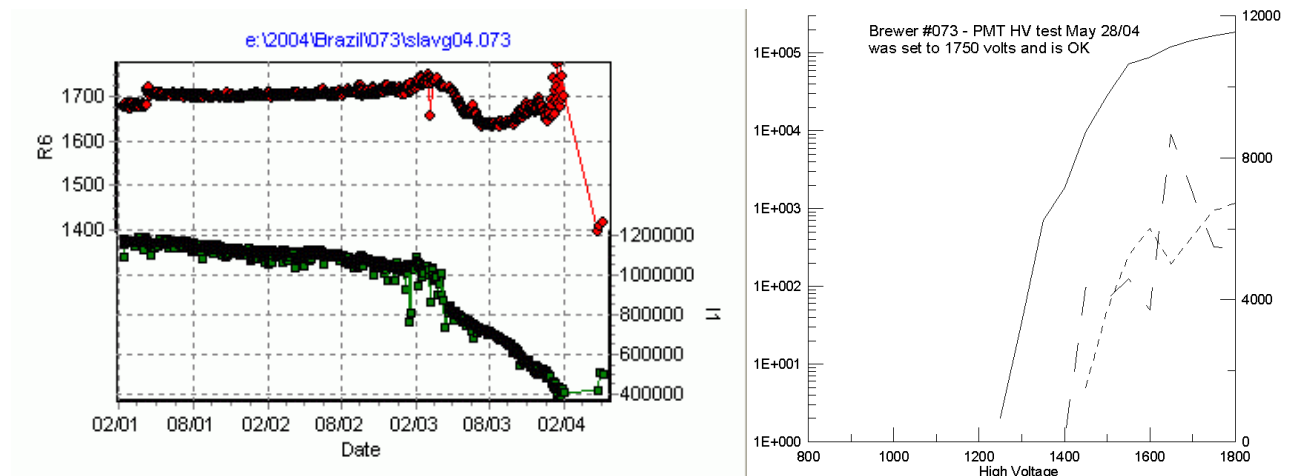
Below is a graph of the SL R6 (ozone) ratio and F1 counts results since 2001, which show the major decrease occurred in 2004 during the period when instrument was not working. The high voltage test results are shown on the right and show that the PMT requires higher than normal voltage to operate properly and was set to 1700 volts.

#073 - pmt filter cleaned, shutter motor replaced, adjust corr. lens on #073, pmt is weak., R6 was 1410

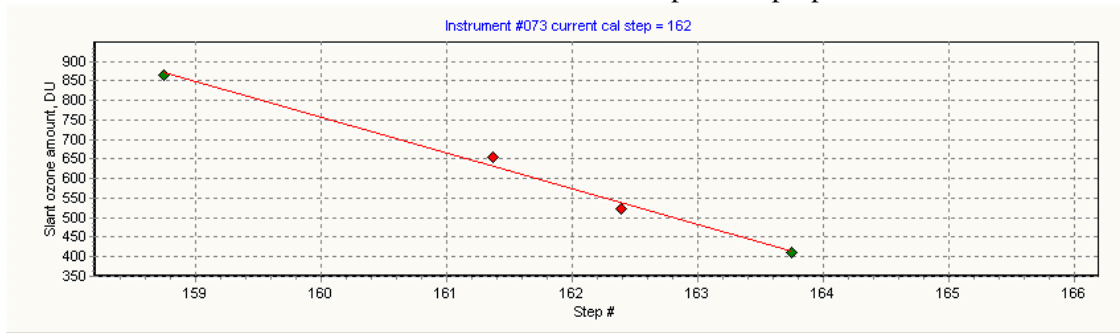
Below are the sun scan results from #073 which show cal step 162 is proper.

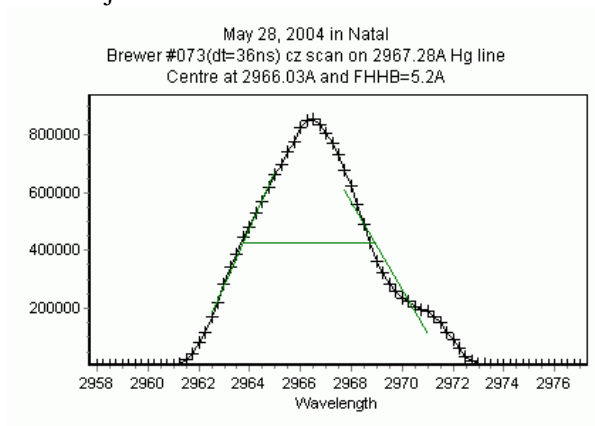
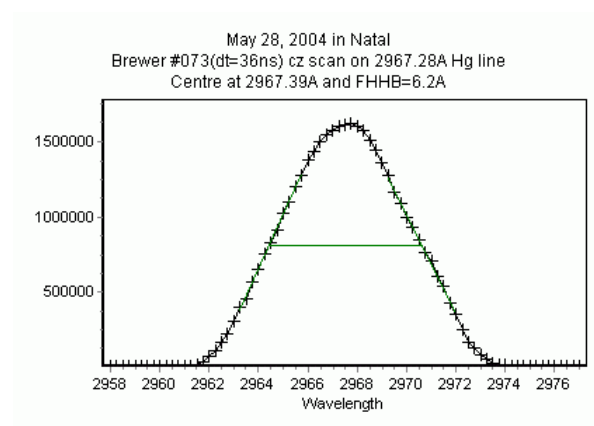
Below are two scans of mercury lamp line 296.7 nm. which show the improvement in slit function after a small adjustment to correction lens.

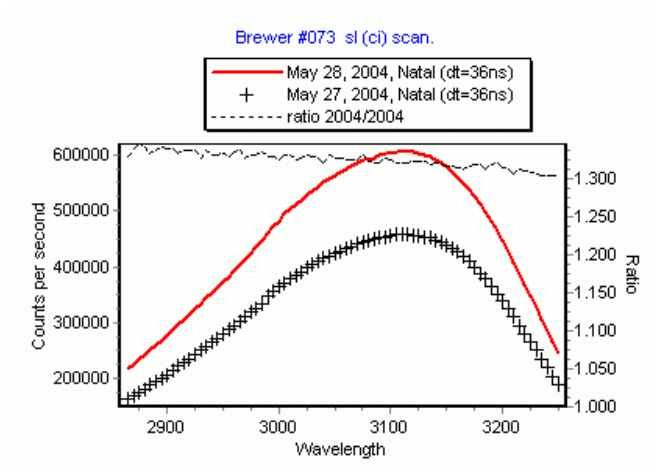
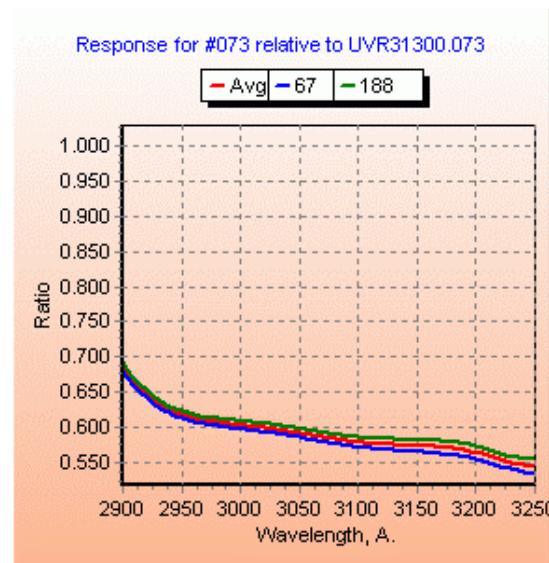
After servicing the sensitivity increased by 30%, as shown below in CI scans of standard lamp. In the next graph the final response file (uvr15104.073) is compared to the 2000 response file. Note that the instrument sensitivity is ~40% lower which indicates likely that the PMT filter will need to be replaced in the near future, especially if SL ratios become instable.

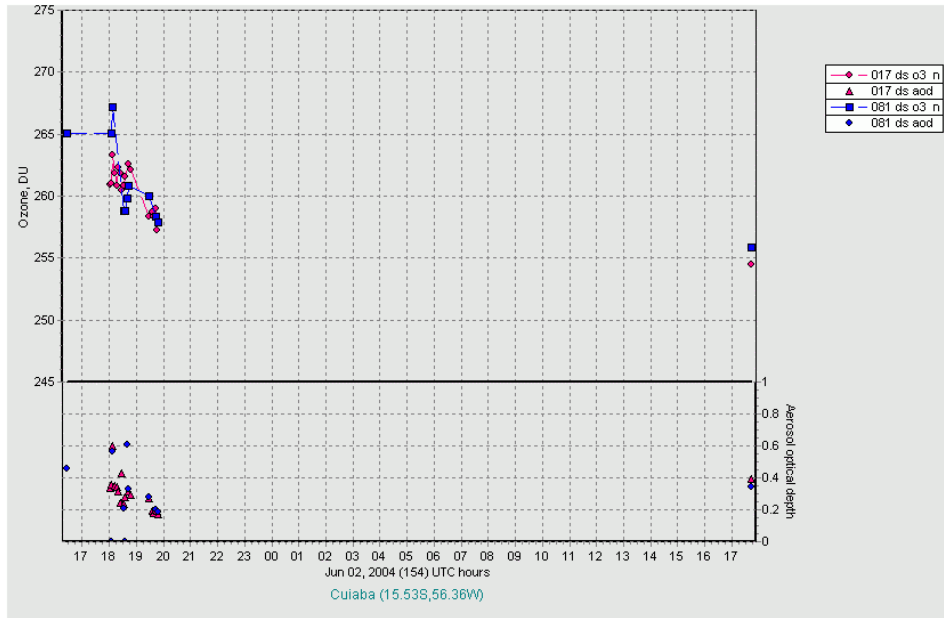
Below are the final Ozone/SO₂ results over two days with #017. The ETC constants were not changed (were 2960/2715 since 099/03) when standard lamp ratios were and continue to be 1780/3220. Strange tracking corrections had to be made and problem was traced to zenith steps per revolution constant set at 2710 instead of 2816. It is suspected that this would affect some previous data when sun was being partially blocked.

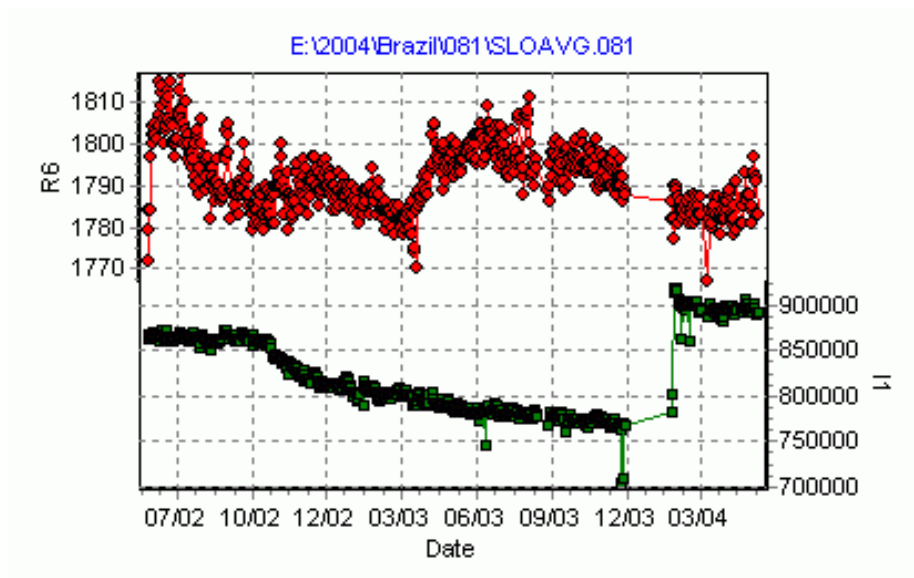
Below is graph of the SL R6 (ozone) ratio and F1 counts results since 2002, and on the next page are graphs of dead time DT, HG intensity and SL scans comparison to 2001 - which show the quite good stability.

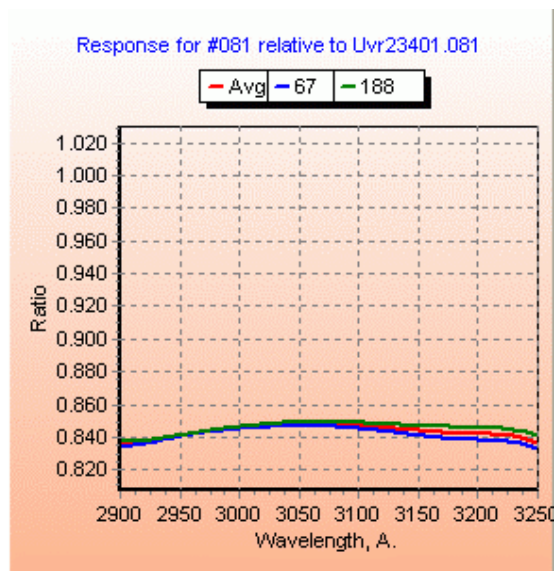
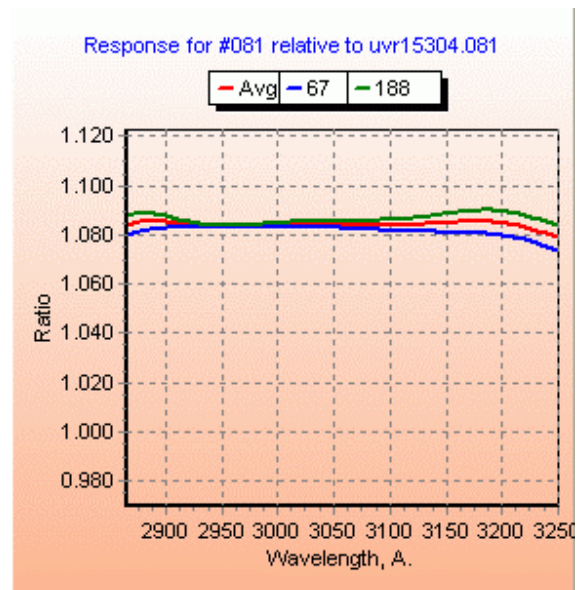
Reference left graph below showing that the UV sensitivity has decreased by 16% since 2001, this was after the uv prism alignment (constant) was improved (TU test), note the sensitivity went up 8% after.

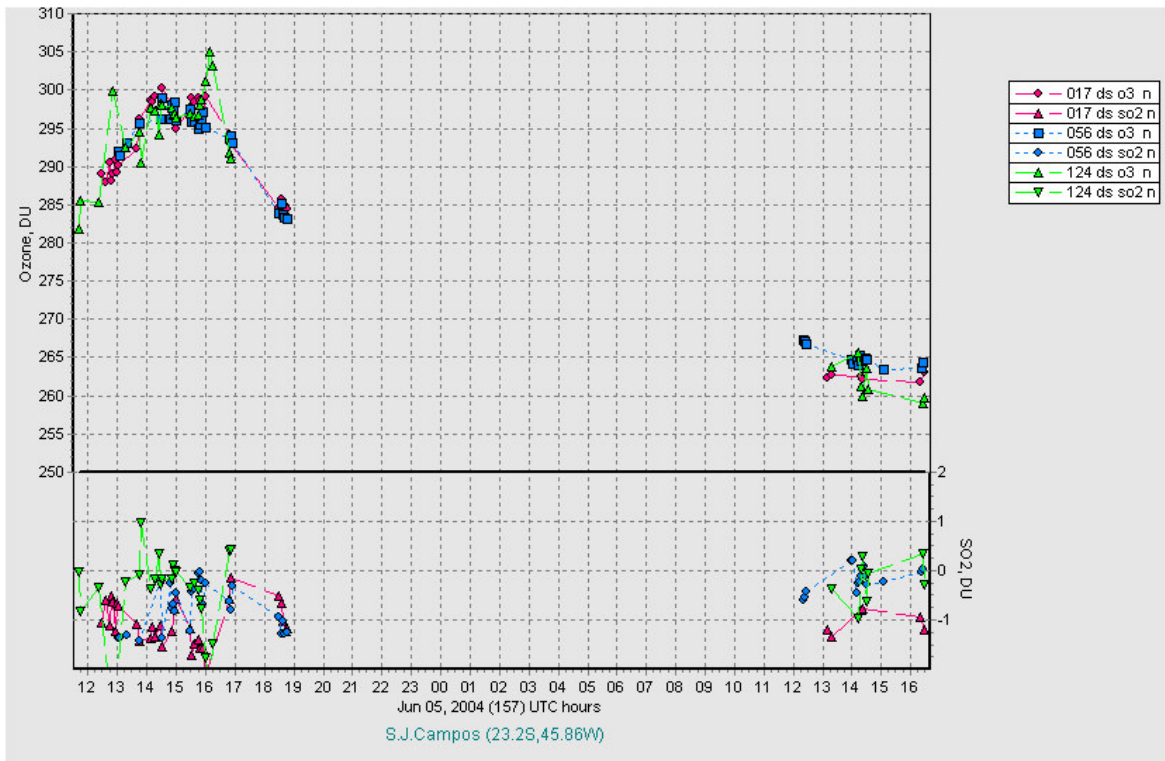
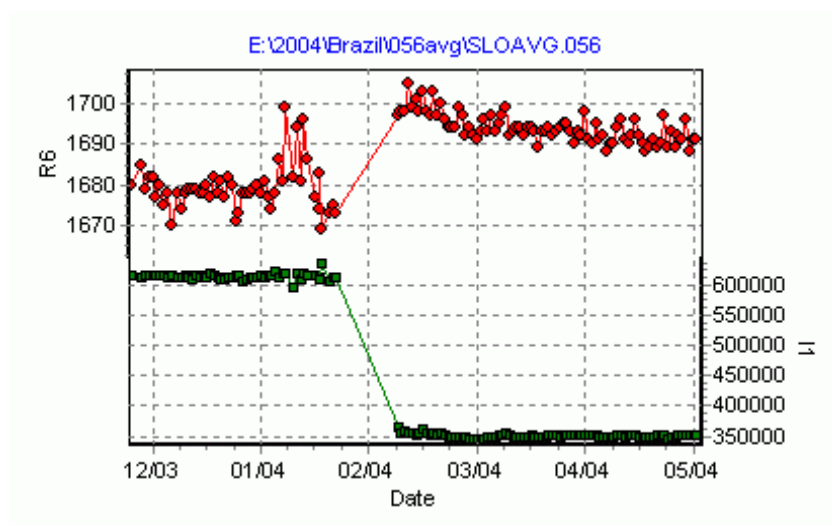
Below are the final Ozone/SO₂ results over the two days with #017. With no changes the ozone was ~1% lower with #056 and ~2% lower with #124 when compared to the standard #017. The ETC constants in use with #124 had been adjusted one year ago to 2670/2668 and now due to recent decrease in SL ratios to 1415/3030 the ETC's were adjusted to 2640/2650. For #056 the ETC constants have been set at 2845/3000 since 077/00 and now were adjusted to 2830/2900 for standard lamp ratios of 1690/3390. The photon counter board was exchanged in #056 to hopefully reduce errors. Corrections to constants have been done externally at INPE based on SL ratio values.

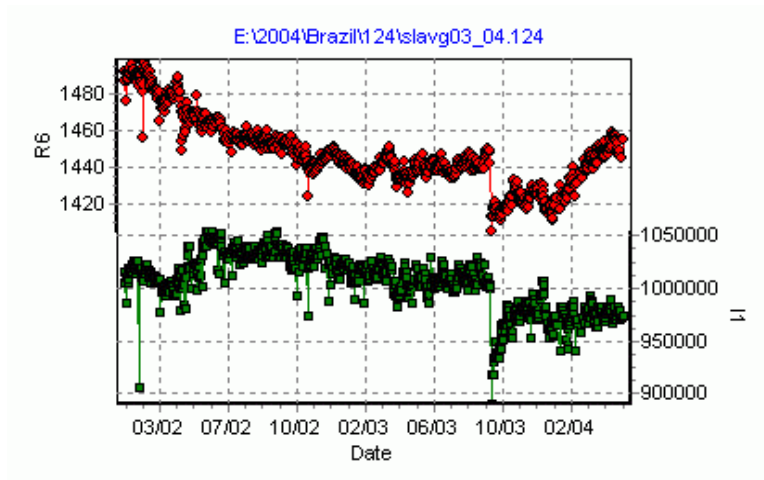
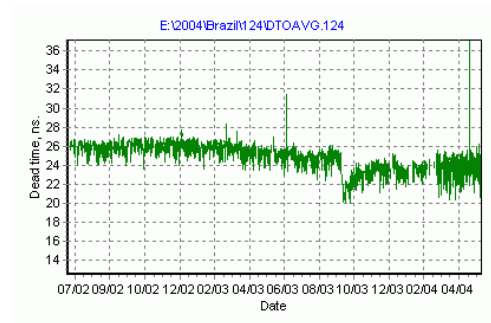
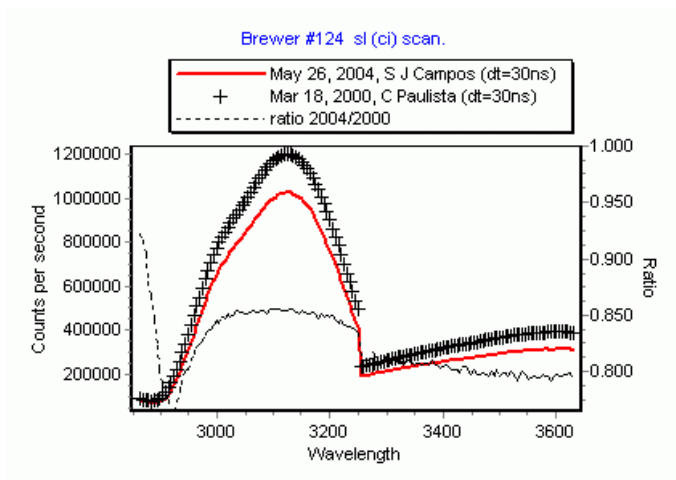
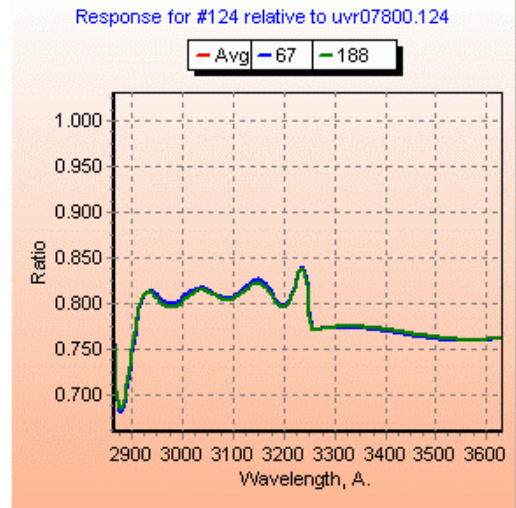
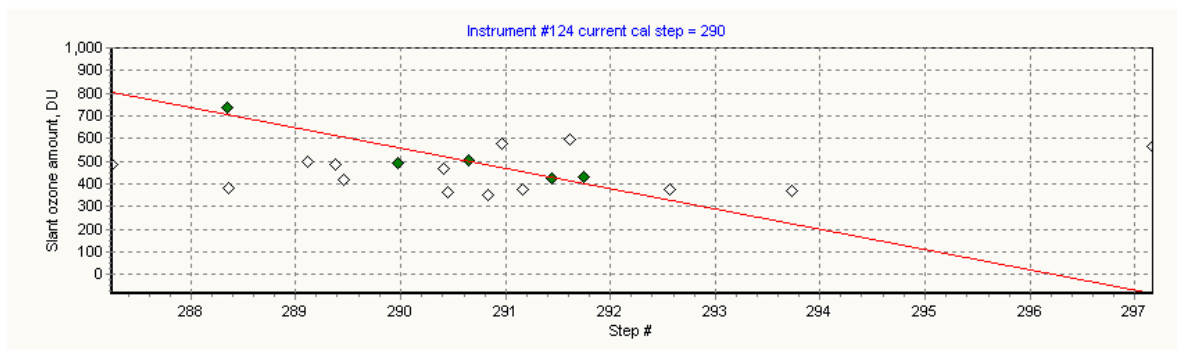
Below are SL, DT and other graphs of **Brewer #124**, normally located at C. Paulista site. Note the somewhat unstable SL ratio R6 and stable DT results since 2002. Note the decrease in sensitivity of 20-24% since 2000, which is shown in internal standard lamp and external UV lamp scan test results.. The sun scan results show cal step 290 is proper.

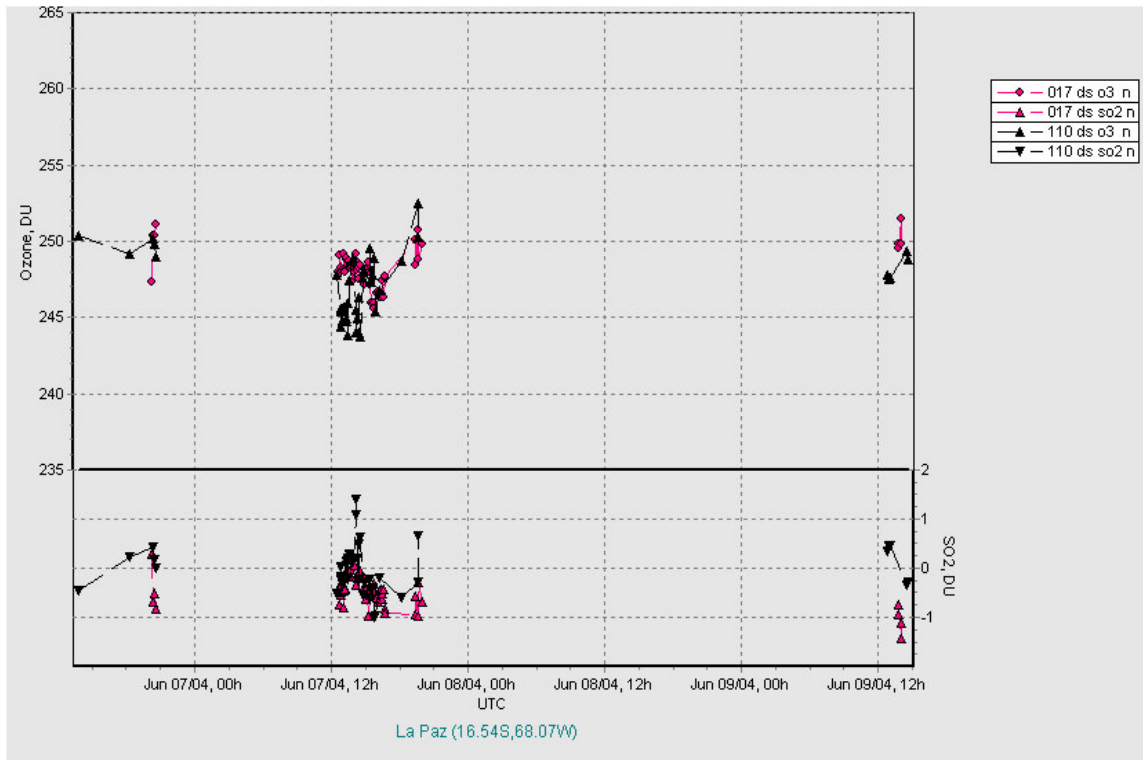
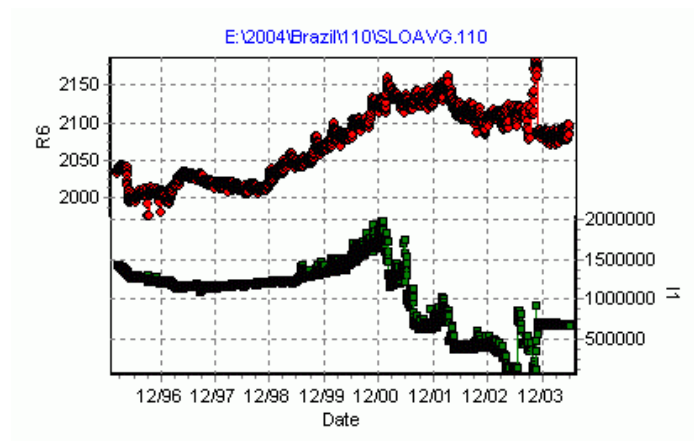
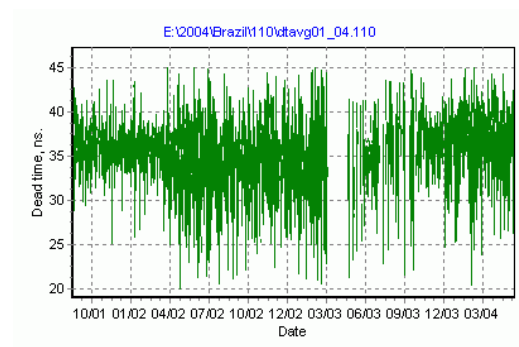
The initial ozone from #110 was 1-2% lower than #017. Below are the final Ozone/SO₂ results over three days with #017 when the ETC constants were reduced from 3365/3660 to 3305/3620 for SL ratios of 2080/3935. The instrument has been fairly stable for the past 3 years. The instrument has had a lower than normal maximum wavelength scanning limit (360 instead of 363nm) and so adjustments were made to the mirror to correct this weakness. So now standard UX scans can be done. On the last day some boards were damaged by an electrical shorting accident and had to be replaced by borrowing from #017.

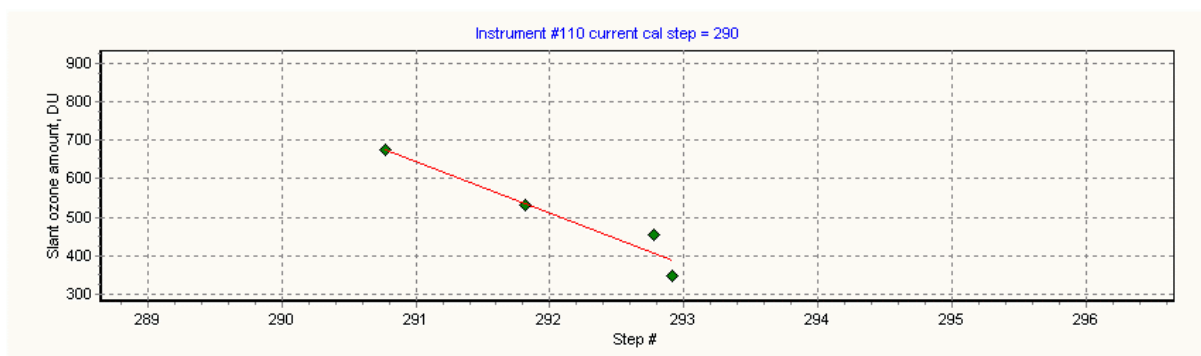
After the above sun scan tests the cal step was adjusted to step 292 on #110. The graphs below show a normal slit function and that the UV sensitivity has decreased by 10% since 2001.
